# A Rehabilitation Story Lowman Hall - South Carolina State University – Orangeburg, South Carolina

Alfred A. Lindsay, AIA NCARB, Architect (SC State Campus Architect)
Associate Director, Office of Planning & Construction
South Carolina State University
803-516-4853

John McLean, AIA LEED AP (Project Architect)
Watson Tate Savory Liollio Architecture
1316 Washington St. Columbia, SC
803-799-5181
jmclean@wtsliollio.com

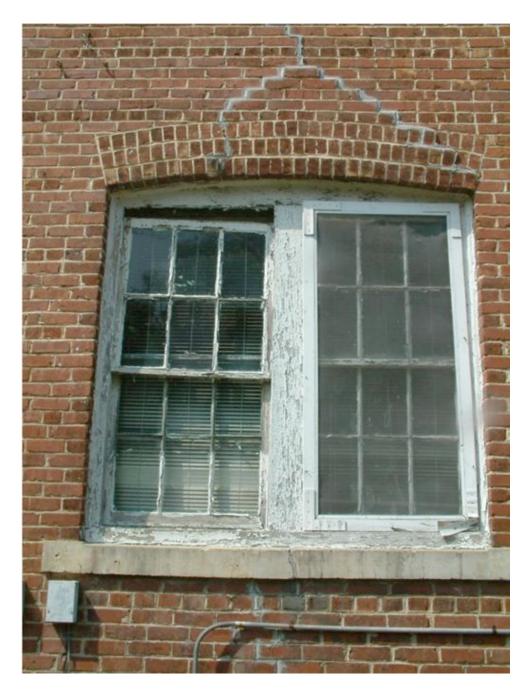
Weathering & Settling

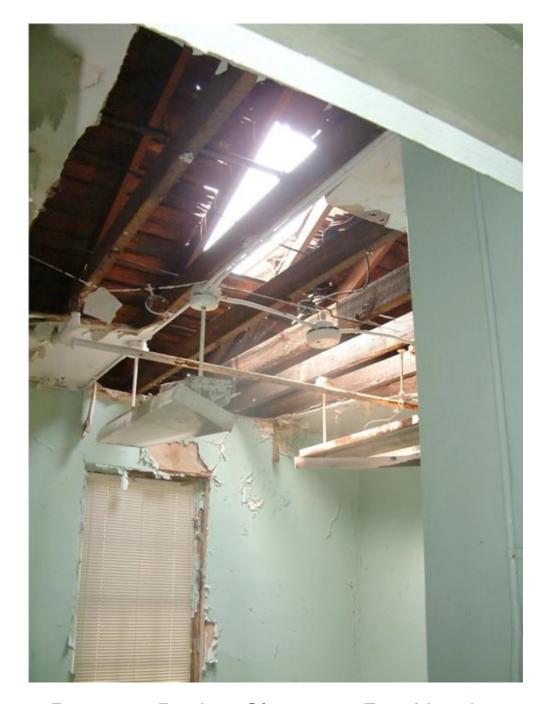
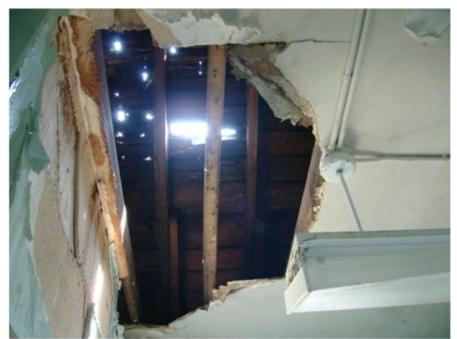
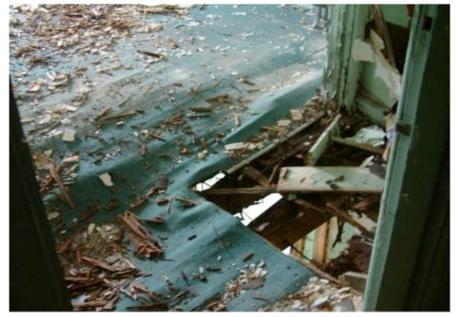
Damage During Closure – Roof Leaks

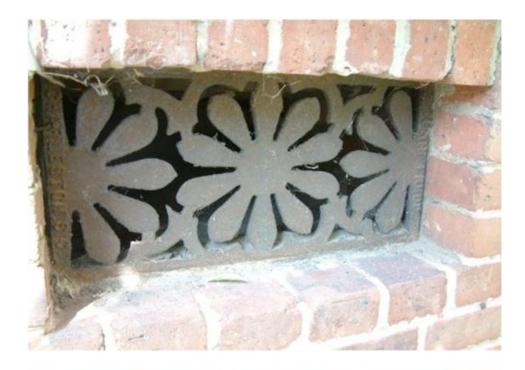
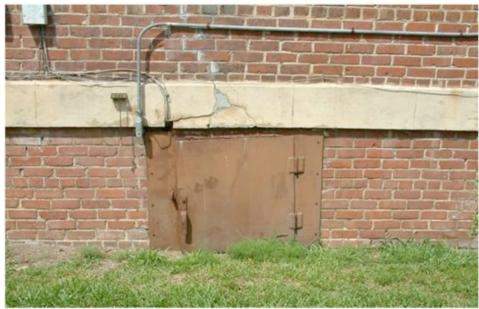
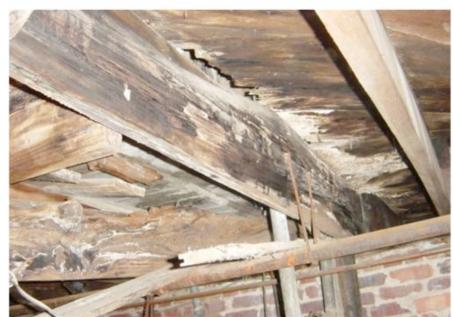
Damage During Closure – Steam Leaks

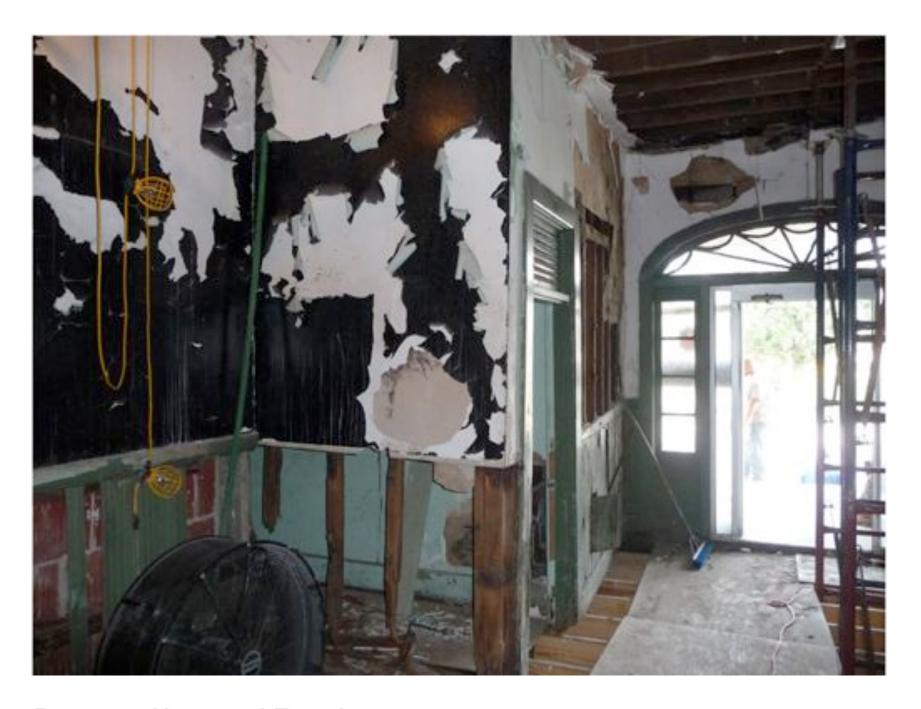
**Plaster – Unsound Framing**

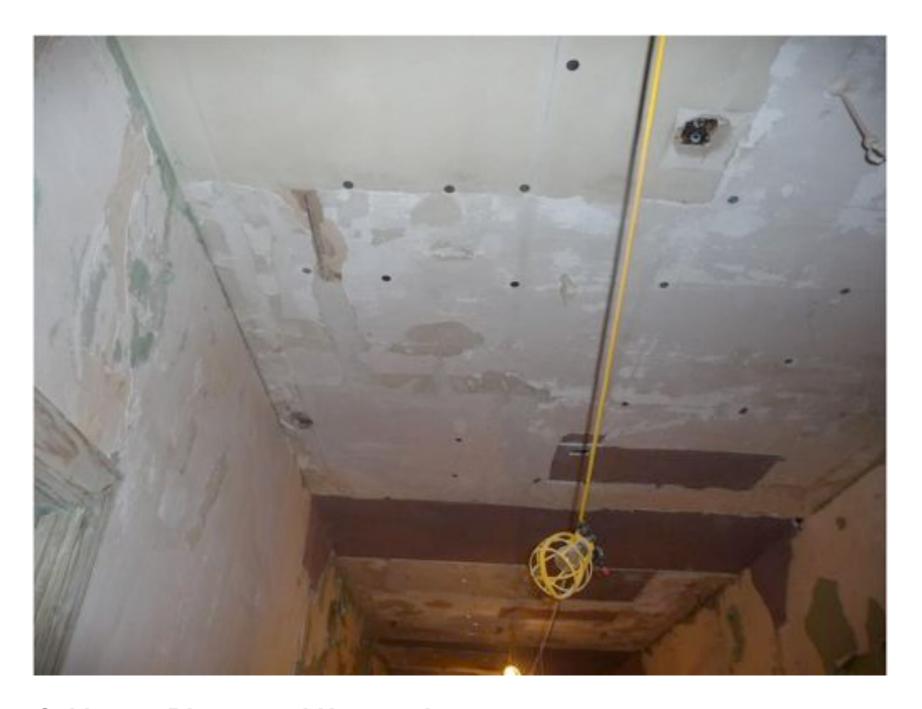
**Ceilings – Discovered Unsoundness**

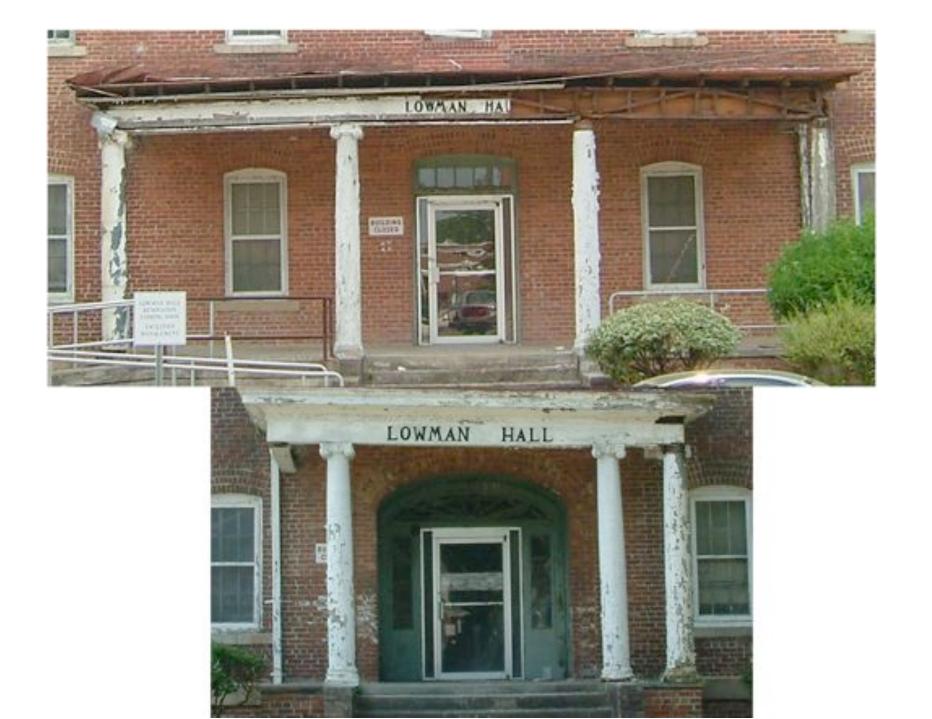
**Wood Columns – Existing Conditions**

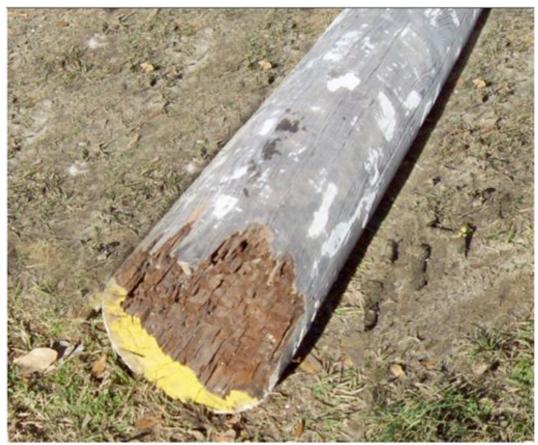
Existing Condition: decay at lower end of shaft.

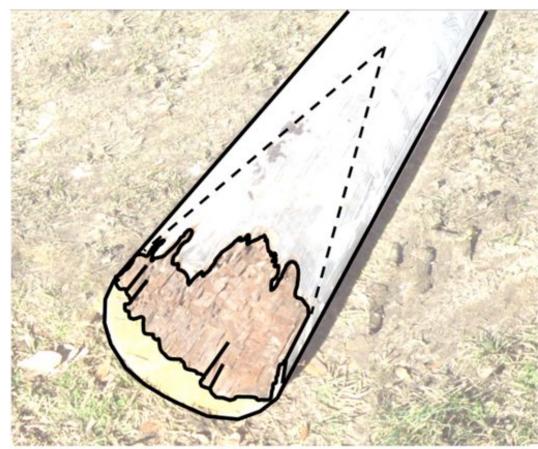
A cone-shaped area of decay may extend up into the center of the column, surrounded by outer sound wood
